**TREATMENT OF LAND SLIDE AND EROSION CONTROL PROJECT  
UNDER TDET - SOUTH SIKKIM  
2004-05 to 2007-08**

**ENVIS CENTRE SIKKIM**  
*On Status of Environment & its Related Issues*

**C. Lachungpa, IFS  
Conservator of Forests (Land Use & Env.)  
Forests, Env. & Wildlife Management Department  
Government of Sikkim**

**TREATMENT OF LAND SLIDE AND EROSION CONTROL WORK UNDER  
“TDET” PROJECT - SOUTH SIKKIM  
2004-05 to 2007-08**

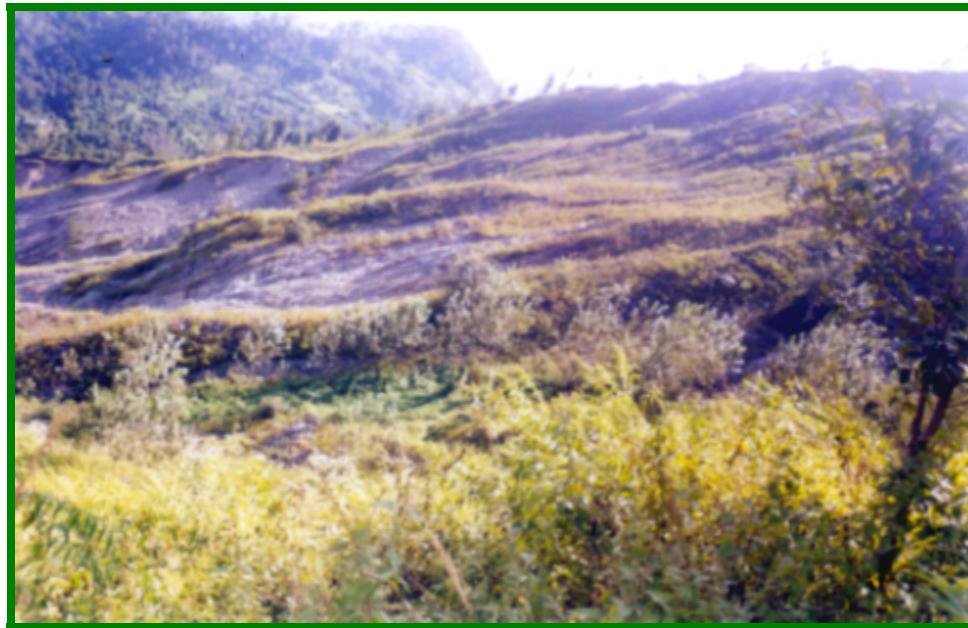
*Active landslide of South Sikkim*

The studied landslides are still very active and indeed needs extensive scientific research prior to the implementation of any conservation and recreation measures. So within target severe landslides, scientific analysis of vegetation density, enumeration of soil profile, and study of streams origin and its runoff velocity has been carried out during field visit.

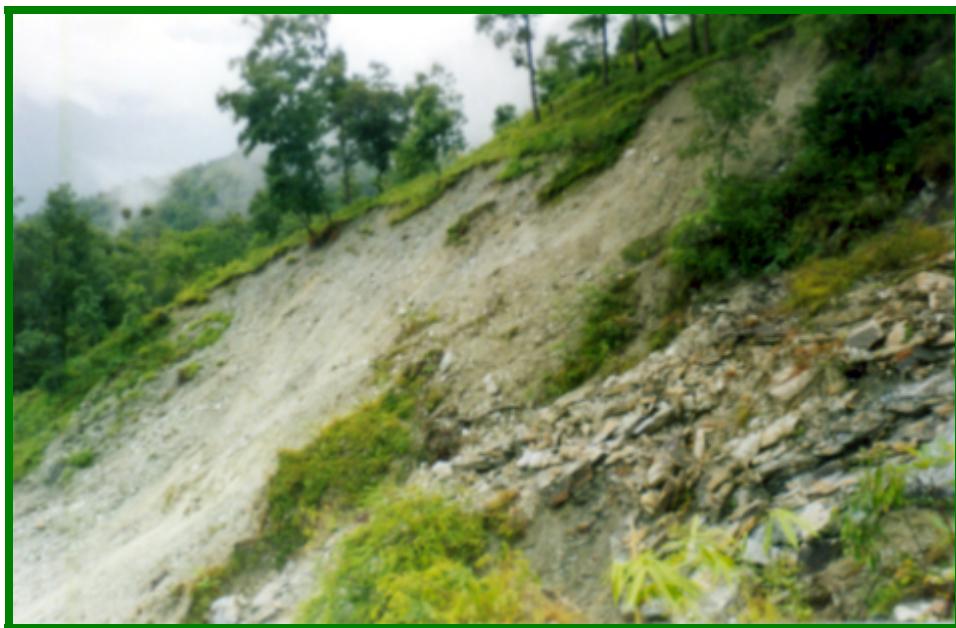
Degraded  
land due to  
Soil Erosion

In due course of survey, it is fairly noticed that the condition of slope is very stiff and erosion continuous, most probably due to three downward streams which intersect the slide longitudinally at different intervals. As a result many gullies are formed, however parameters like intensity of rainfall, velocity of wind, temperature, edaphic factor are also responsible for erosion. The streams were originated at the top of slide and rapid run off erodes the soil debris which ultimately mingle with the Teesta River at bottom nearby. The slide was so severe that the top-most fertile soil was completely washed away so that the probability of plantation is almost null even though cutting of many bamboo species, trees like *Anthocephalus cadamba*, *Erythrina indica*, *Bischofia javanica*, *Terminalia myriocarpa* were planted within the slides seeing the appropriate land.

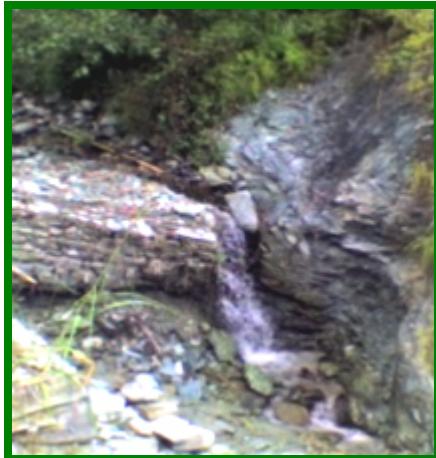
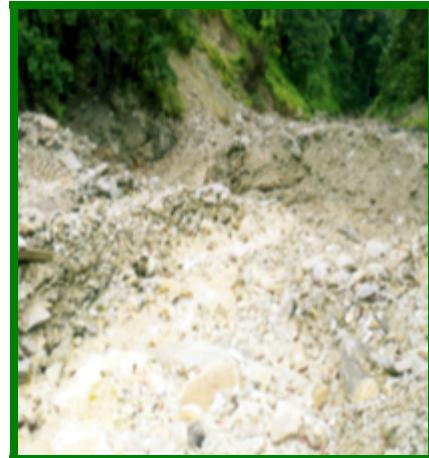
Turung erosion itself is the origin of three streams. It was observed that under ground water sprout out naturally from the erosion which later turns into high potential runoff streams. Two streams flow longitudinally downward bordering the erosion slide from side-wise and one stream flows just through mid vein dissecting the slide.

*Streams of Turung Landslide*

All streams finally meet at the base line and mix with the river Teesta. Average Speed of runoff has been calculated as 20 Km/hr, 19 Km/hr, and 25 Km/hr respectively in the month of December however velocity does not remain constant throughout the year because during monsoon season, naturally runoff velocity increases due to either heavy rainfall or over seepage of waste water from different sources. The speed of runoff also depends upon the condition of slop, turning of stream, etc.

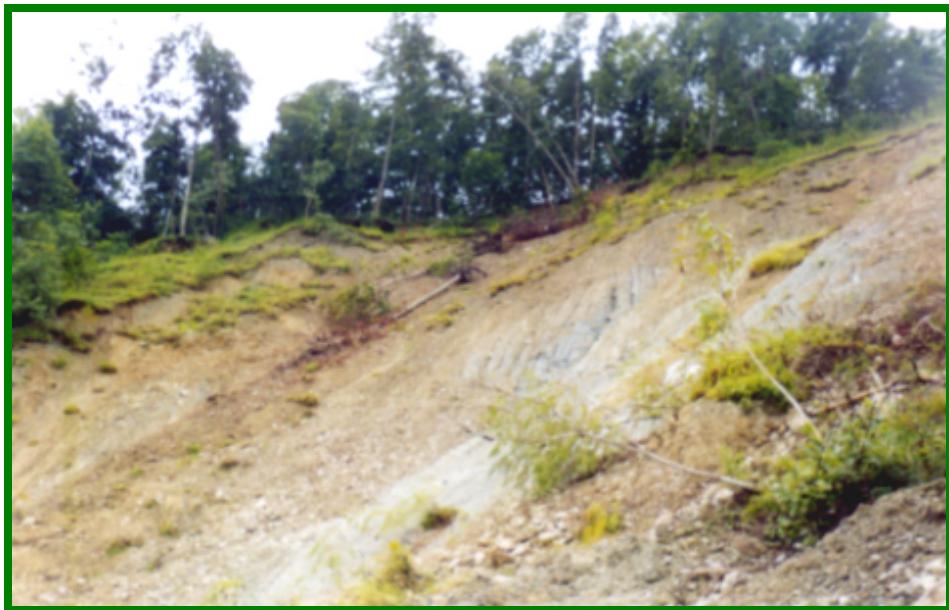
“Donok” soil erosion of South Sikkim occurred in 1968 due to heavy rainfalls and is included in severe erosion which dragged off approximately 6.925 ha forest land. This landslide is being continuous threat for the inhabitants of Bimbung village situated just at the top of landslide.

*Degraded Forest Land in Donak, South Sikkim*

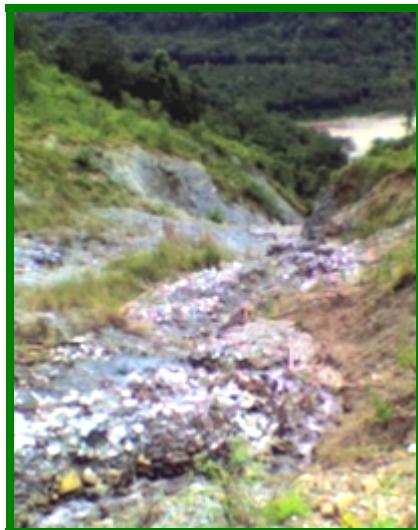
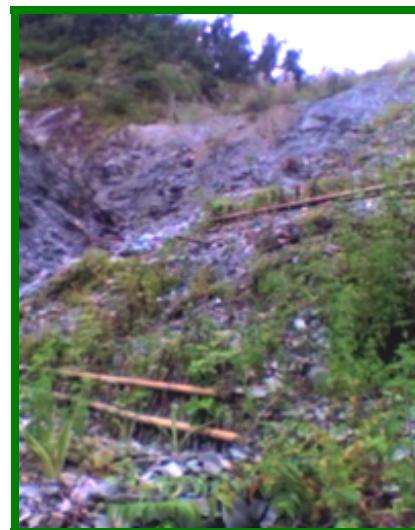
History reveals that Donok erosion occurred due to heavy rainfall of 1968; however that was only limited to initial cause of landslide. Also today, landslide is active due to runoff energies of streams. In due course of investigation, it was fairly noticed that downward stream which flows from the Bhimbung Busty transect the slide from the middle and erodes the bulk of soil debris creating the gullies. At last this stream merge with the river Teesta.

*Streams of Donak landslide with Baseline of Teesta river*

During the month of December, this stream flows with the average speed of 15 Km/hr but speed is mainly depended upon the slope steep, bending of stream, and mass of water. The stream velocity increases as it approaches the monsoon season. If water of this stream is diverted from the source by constructing catch water drain to other arid places then erosion can be controlled to some extent.

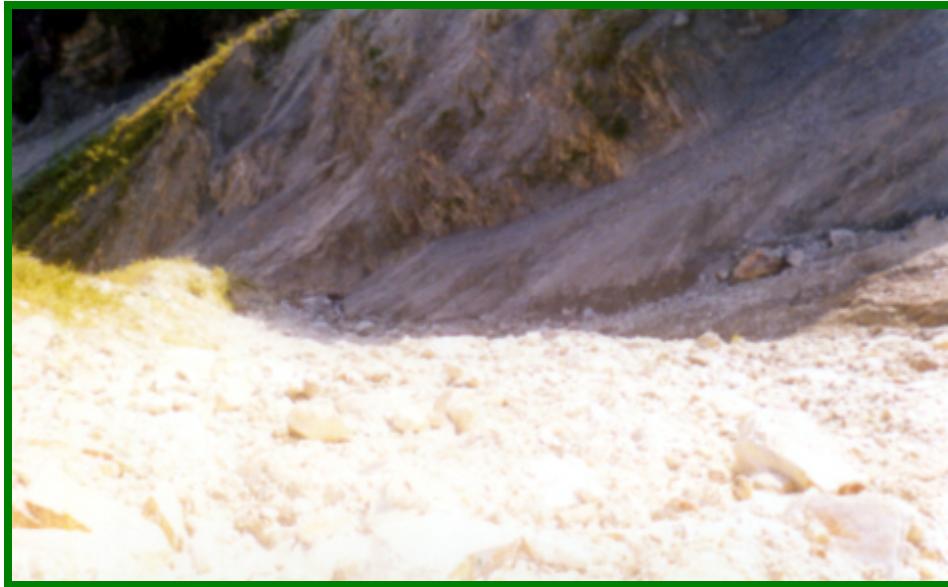
"Seti Khola" land slide is so far considered as biggest and very severe erosion of South Sikkim which haul approximately 87.65 hector forest land. Traced back to history, it was revealed that slide occurred in 1968 due to over rainfall and panic floods. This slide provoked peril situation for the inhabitants of the Katang Busty situated just at the top of slide. Seeing the range of devastation caused by slide, many houses were evacuated for safety. The erosion Slide is sandwich between  $88^{\circ} 28' 18''$  and  $88^{\circ} 28' 51''$  East latitudes and  $27^{\circ} 08' 51''$  and  $27^{\circ} 08' 31''$  North longitudes. Main cause of erosion is Seti Khola which flows diagonally from the side and comes at the middle in the baseline of slide. In rainy season this stream roars with the flood and drags the soils from the bottom of slide. Some portion of slide is very stiff and rocky so establishment of climax plant succession is very much disallowed naturally.

*Seti Khola landslide South Sikkim*

The weathering of rock is very prominent within this slide due to hydraulic pressure caused by heavy rains which increases the weight of the rock at clefts which comes under gravitational force and finally slips or fall off. This slide itself is the origin of several springs from where underground water spout out naturally which flows downwards creating the gullies and eventually turns to streams by approaching the baseline.

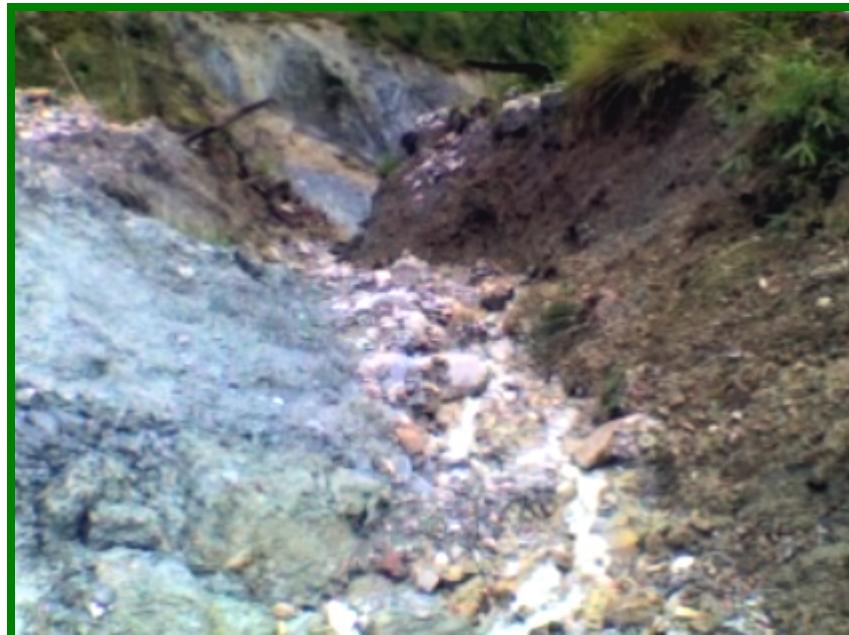
Though South Sikkim receives less rainfall as compared to other places of Sikkim, unexpected seasonal rainfall of 1968 was the main cause of Seti-Khola landslide. Since then number of streams originated within the slide and made the erosion very much active. In Nepali terminology “Khola” means river and Seti-Khola flows diagonally from the slide and ultimately reach at the mid-base of slide. This river flows with very high speed of 30 Km/hr throughout the year even one can generate the electricity from this river. The velocity reaches optimum during spring season. The runoff energies of this river drags the soil debris from the bottom, so occupational land and many villagers were evacuated from the top of the slide. If cemented wall is constructed along the river bank then it will guard the further dragging of soil from bottom and give proper channel to the water flow.

*Downwards Streams of Seti Khola*

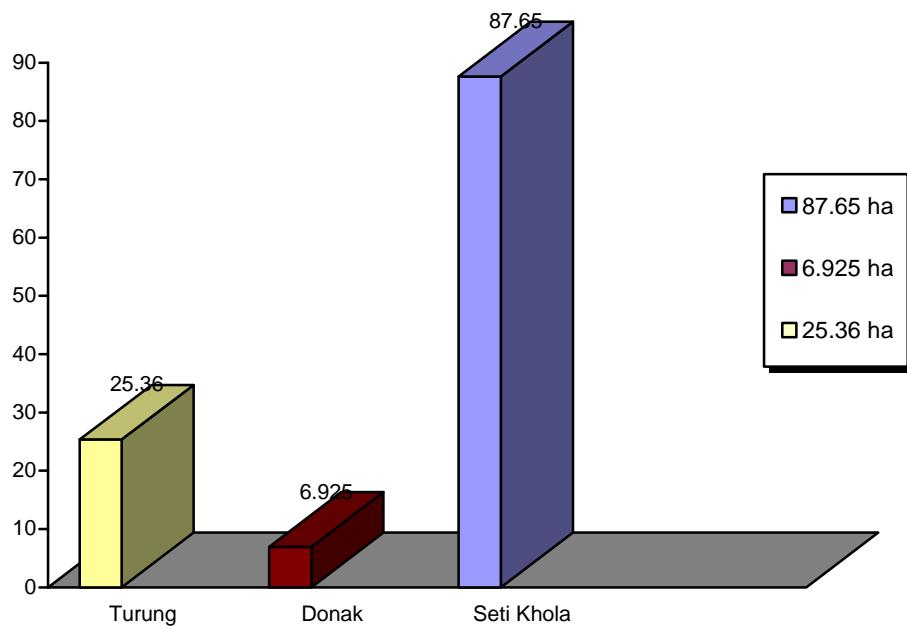
Fig. 1. As per the survey of 2007, conducted by the Forest Department, Government of Sikkim, the total area under severe Soil erosion in South Sikkim is approximately 119.935 ha.

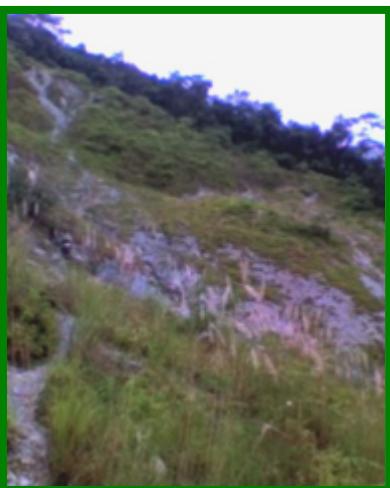
Acclimatization of Poaceae grasses in degraded nutrient deficient landslide

The outcome survivalists of plantation is nearly 80% but soil is very acidic and nutrient deficit, so once approaching to unfavorable seasonal condition, vegetation could change to nude land. In this condition, if seed of *Schima wallichii* was sown then it can withstand in the acidic soil with prolong dryness. Plantation of any leguminous plants in the degraded land may enrich the soil with nitrogenous fertilizer. Scientific approach behind this reason is that these plants produced root nodule association with the nitrogen fixing bacteria which fix the nitrogen to soil and enhance the fertility status. This all includes in biological and eco-friendly method to implement for the conservation of soil erosion.

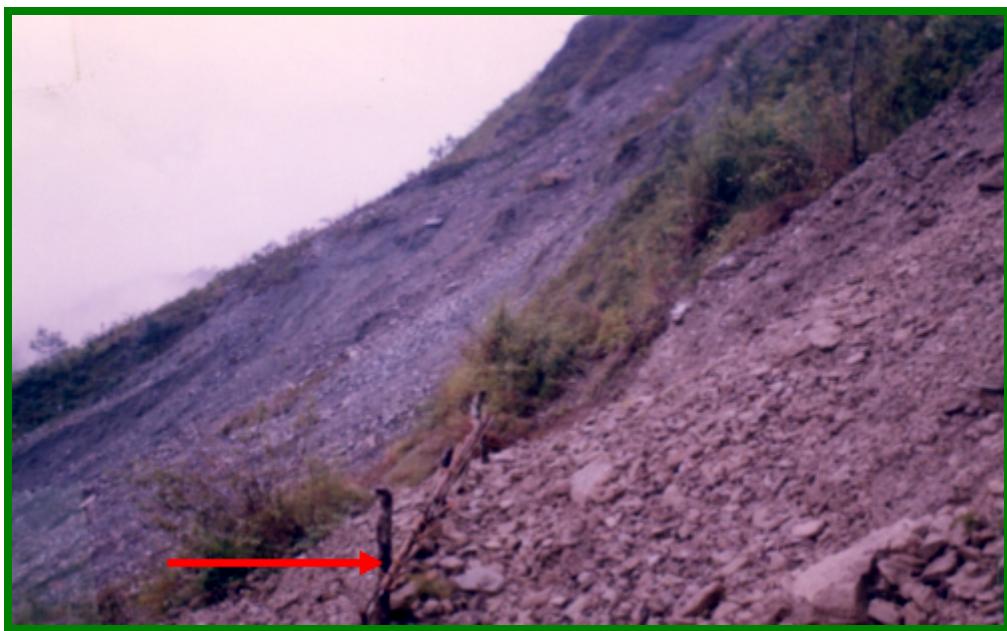
It was found that percentage of gravel and sand is very high in each of the sample and fertility status is also very low due to this reason, vegetation propagation is very difficult even though we can seek out some measures to improve the soil profile either through biological or mechanical method. Recent finding of many scientists reveals that some plants fixed nitrogen in soil for e.g. leguminous plants which can be grown in such arid zone of gravel and sand.

*Toppled Gravelly Loamy Sand partially checked by bally benching*

After fertility test and soil profile analysis, it was found that "Gravelly Loamy" sand is predominant through the catchment area of erosion slides in South Sikkim. Due to the highest percentage of gravel and sand, water holding capacity of soil is very negligible and hence average moisture contains of soil is restricted to only 7% per gram of soil sample through the landslide. Gravel percentage is very high and water can easily pass through it, as a result flush of rain may erode huge mass of gravel with sand in slope. It is known from the Soil fertility test that soil is also NPK deficit with acidic condition. So, this poor condition of soil does not permit the growth of any vegetation in erosion slide even Xerophytic plant can hardly survive. Plants like *Alnus nepalensis* is very dominant in landslide of Sikkim because it has got ability to fix the atmospheric nitrogen in soil which finally converted to nitrate fertilizer with the help of some bacteria encysted inside the root nodule of this plant even though this plant also got very less density around the landslide of South Sikkim.

In order to improve the fertility status and soil profile in South Sikkim, mulching method is applied in the erosion slide in extensive manner. Mulches of leaves, stubbles, straw etc. totally covers the surface layer of the soil which prevents the organic top layer from being washed away by rainfall. Mulches decay afterwards due to the microbial activities which enhance the organic content of soil and also help in the retention of moisture in soil. So, the method of mulching is significant in various ways to enhance the fertility status.

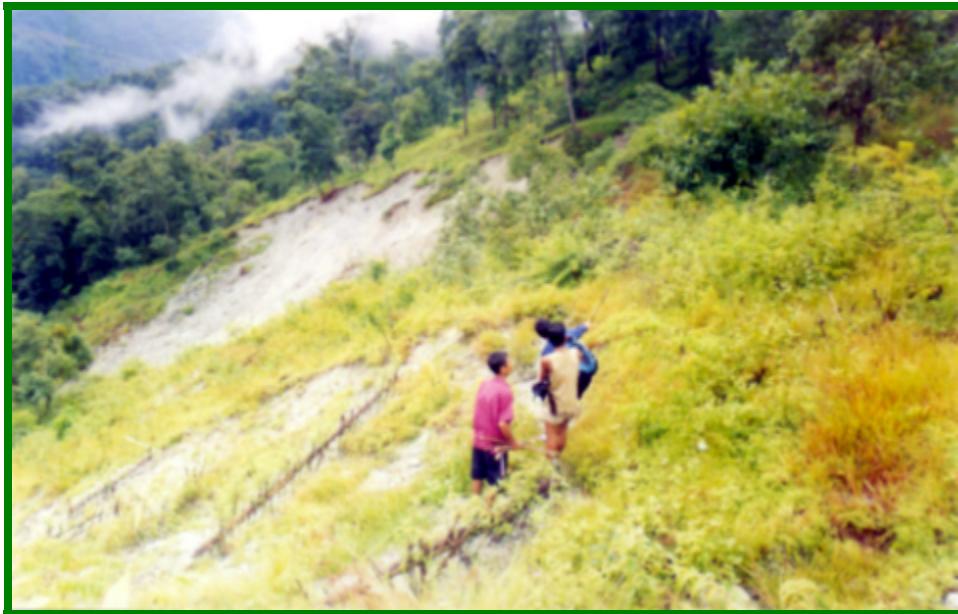
*Plantation of cuttings across the slopes of landslide*

**Use of Vegetation:** Vegetation which covers the ground surface well and has extensive root system was used to reduce soil erosion in South Sikkim. Plant canopy was planted along the contour of landslide to protect the soil from the adverse effect of rainfall. The grasses and legumes are transplanted in degraded land which has potential to produce dense sod to check the further erosion. This vegetation also provide organic matter to the soil. As a result, the fertility of soil increases and the physical condition of soil is improved. Following cropping systems has been implemented to controlling soil erosion -

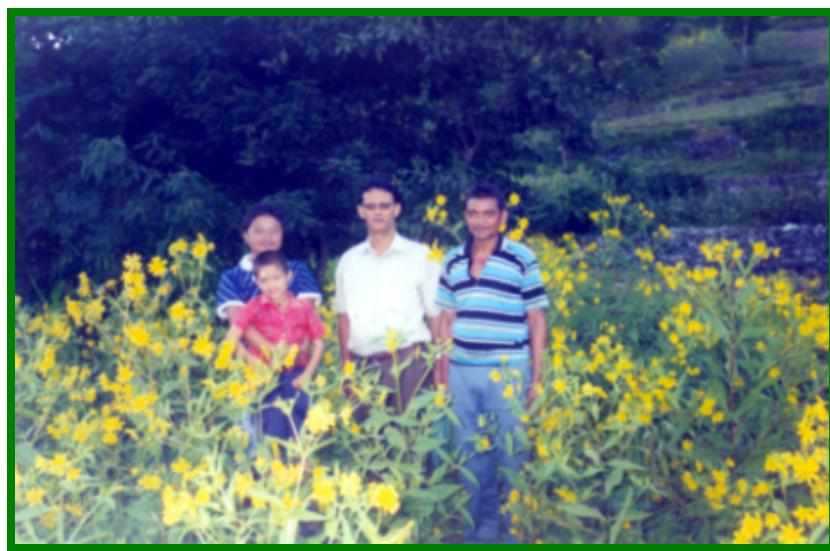
**Crop rotation and dry farming:** This method could be very effective in checking erosion of occupational land surrounding the landslide. It has been observed that on the top of Turung and Donok landslide, people are practicing crop rotation in traditional way because most of the people in Sikkim relied upon seasonal occupation. So in one sense, people are maintaining fertility status and productivity of soil.

*Occupational land just above the landslide*

Land Use & Environment Circle of Forest Department is conducting awareness campaign to assist crop rotation and dry farming in all occupational land surrounding the erosion slide. In occupational land, people are practicing good seasonal crop rotation which includes the sowing of maize, followed by millet, beans, etc. Cultivation of leguminous plant like bean, pea, increases the yield of nitrogen content of soil because most of these plants contain nitrogen fixing bacteria. Aqua culture of any things was already detained in the surrounding area of erosion by providing appropriate compensation for the source income through such land.

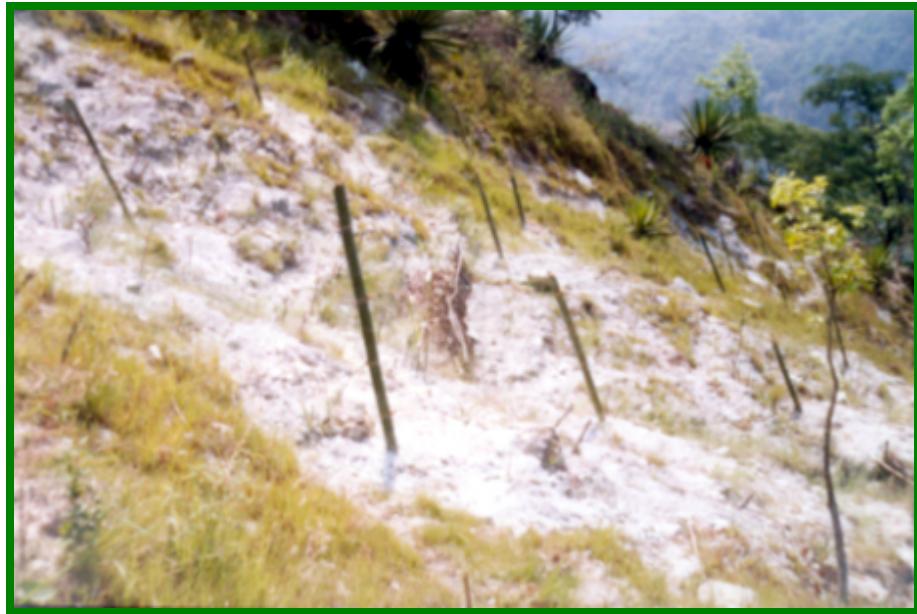
*Bamboo plantation in landslide*

**Afforestation:** All slides are situated under forest area and very challenging for crop cultivation within erosion slide so afforestation is economically best method to implement for the conservation purpose of erosion. Afforestation means growing of forests where there were no forests before owing to lack of seed trees or due to adverse factors such as unstable soil, aridity or swampliness. Along with afforestation, reforestation should be undertaken which means replanting of forests at places where they have been destroyed by uncontrolled forest fires, excessive felling and lopping. Afforestation is the best means to check the soil erosion.

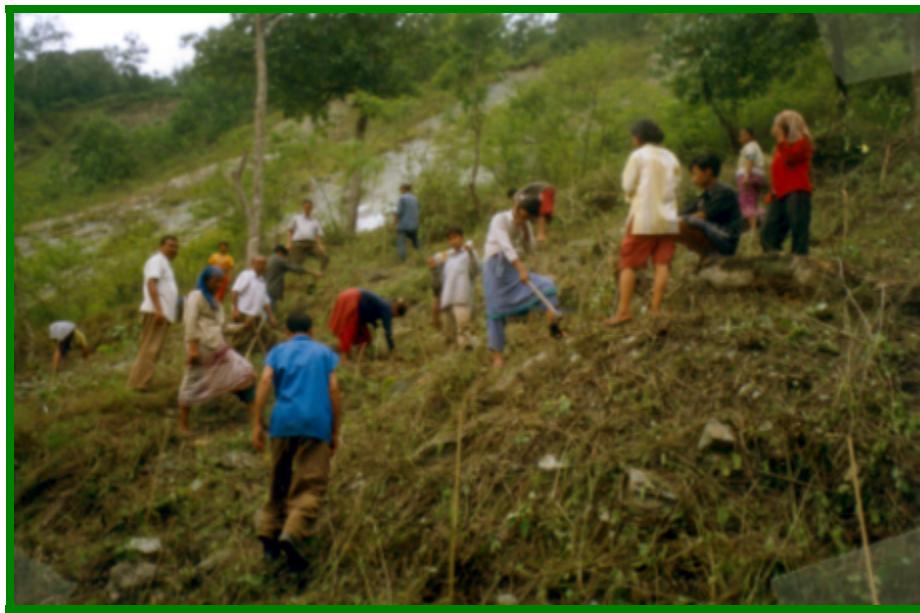
*Plantation around the landslide area to create afforestation zone.*

Aforestation zone has been already created within the slide and plantation of bamboo sp, *anthrocephalus cadamba*, *erythrina indica*, *bischofia javanica*, *Terminalia myriocarpa*, *Agave americana*, etc was done mostly in Turung slide. Soil of all erosion slides is slightly acidic so seed showing of acid loving plants like *schima wallichii*, *alnus nepalensis* could turn to better result in term of adaptation and soil erosion conservation. Trees as windbreaks are planted in arid region which check the velocity of wind. Plantation of trees in short blocks are called wind breaks. Extensive plantation of trees is called shelter belts.

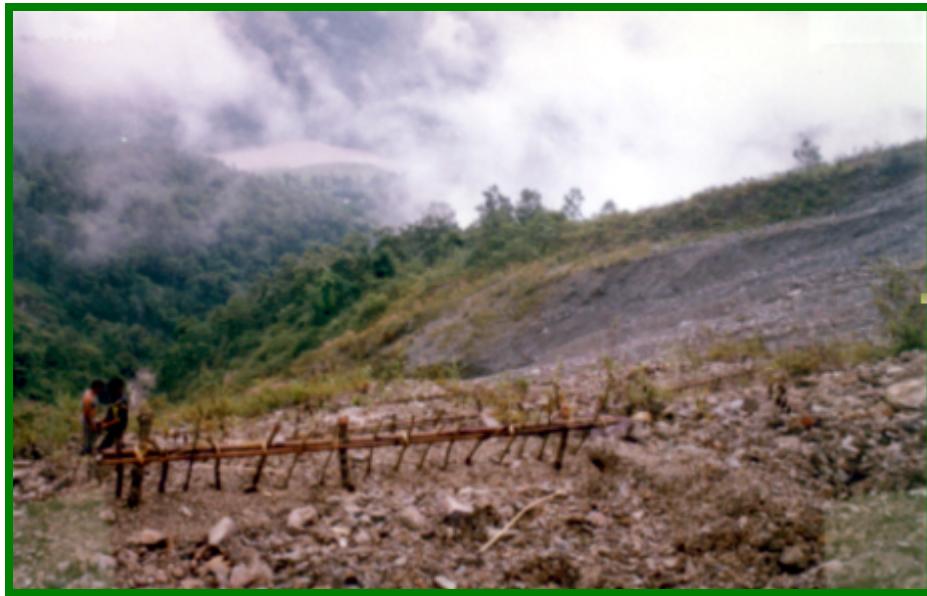
*Bally benching in the landslide to arrest the soil erosion and vegetation regeneration*

**Bally benching:** Bally benching was done in many places within the slides using the cuttings of *Jatropha* sp., *Anthocephalus cadamba*, *Erythrina indica* to minimize the flow of soil debris. Bally benching was more or less successful however some slide is so severe so that it washed away many such fencing. Seeing the severity of slide seed dispersion could be best method for reforestation.

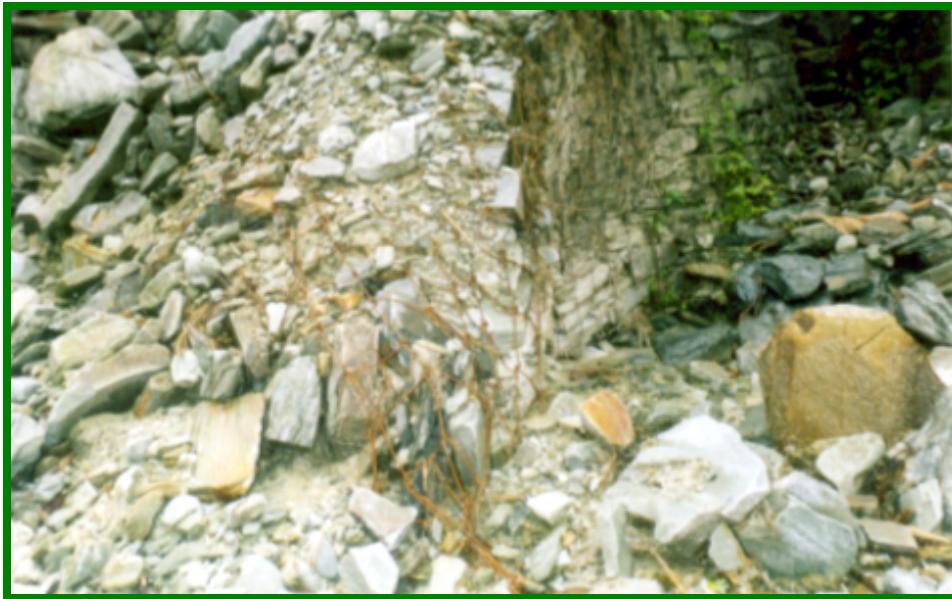
*Damaged wall due to over flood within landslide and portion has been protected*

During the course of the study of the soil erosion and landslide treatment activities, it was observed that the heavy gabion structure in highly severe loosen and fractured faulted configuration area required heavy foundation with G.I. wire sausage stonework combined with cement concrete works to strengthen the pressure of heavy surface runoff added with loose conglomerates and slope gravitational forces. The edge effect of gradual stabilization of landslide with Afforestation of highly adoptable and hardly species renders good impact. Several species of flora both tree and herbs and shrubs have been identified for same purpose.

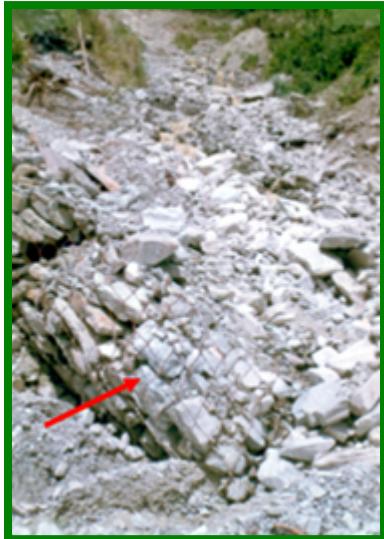
*The Movement of stone debris and boulders across landslide has been partially checked by sausage wall albeit heavy destruction*

**Hand packed stone walls inside sausage (gabion) in landslide areas.** Preference was given to sausage wall among the mechanical method in every landslide of South Sikkim and every landslide was nearly checked by applying sausage wall. In this method the stone wall was covered with G.I sausage to hold the loose stones in place. During field visit, it was observed that most of the erosions are active due to downward streams which loosen and mobilize the soil, so massive bulk of soil began to move down wards. Therefore damage of sausage wall is also very common within the landslide
